# SITE OBSERVATION REPORT – Remedial Investigation – Day 01

PROJECT No.: 170698601 CLIENT: DATE: Wednesday, 9 November 2022

PROJECT: 125 3<sup>rd</sup> Street Third Street Gowanus Owner, WEATHER: Partly Cloudy, 40-62 °F Wind: NE @ 0-10 mph

LOCATION: Brooklyn, New York LLC c/o Orange 6:30 a.m. – 3:30 p.m.

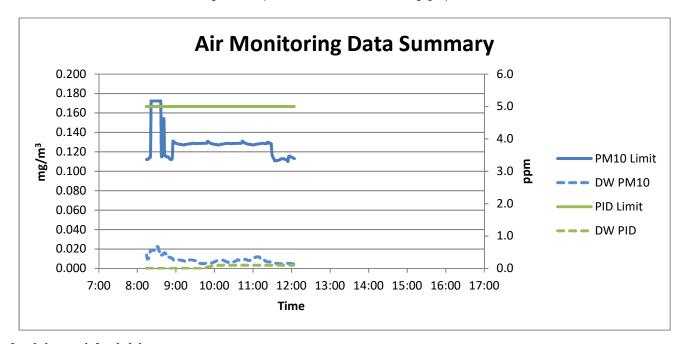
• Langan implemented the CAMP at upwind and downwind locations to monitor VOCs and particulate matter (PM10). 15-minute-average concentrations of VOCs and PM10 were not recorded above the action levels during the monitoring period. No fugitive dust or odors associated with intrusive activities were observed migrating off site. Recorded air monitoring data is presented on the following graph:

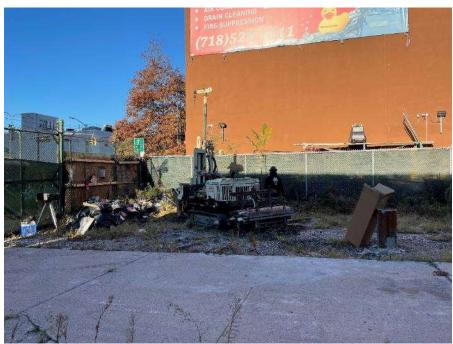
- o **SB16** was advanced to a depth of about 20 feet bgs. No visual or olfactory evidence of impacts was identified.
- Eastern installed one monitoring well in advanced borehole as follows:

Photo 1: Eastern advancing soil boring SB16 (facing southwest).

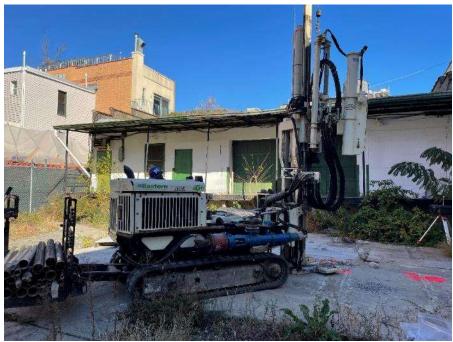
- o **SB14** was advanced to a depth of about 16 feet below grade surface (bgs). No visual or olfactory evidence of impacts was identified.
  - SB15 was advanced to a depth of about 20 feet bgs. No visual or olfactory evidence of impacts was identified

Photo 2: Eastern advancing soil boring SB15 (facing north).
